ROYSONS CORPORATION FIRE TEST REPORT

NFPA 286 TESTING ON 2-PLY 20 oz. NW VINYL WALCOVERING WHEN INSTALLED TO AN INTERIOR WALL

103551102SAT-003

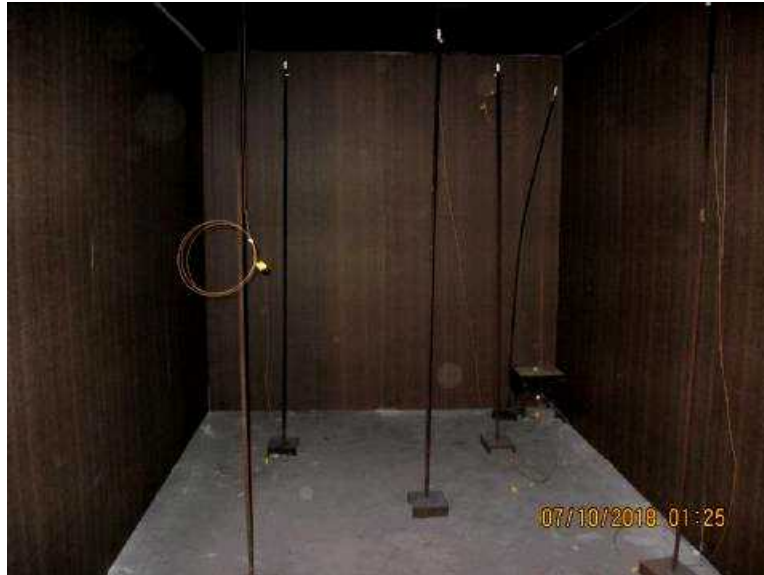
Photo No. 1
Pretest photo

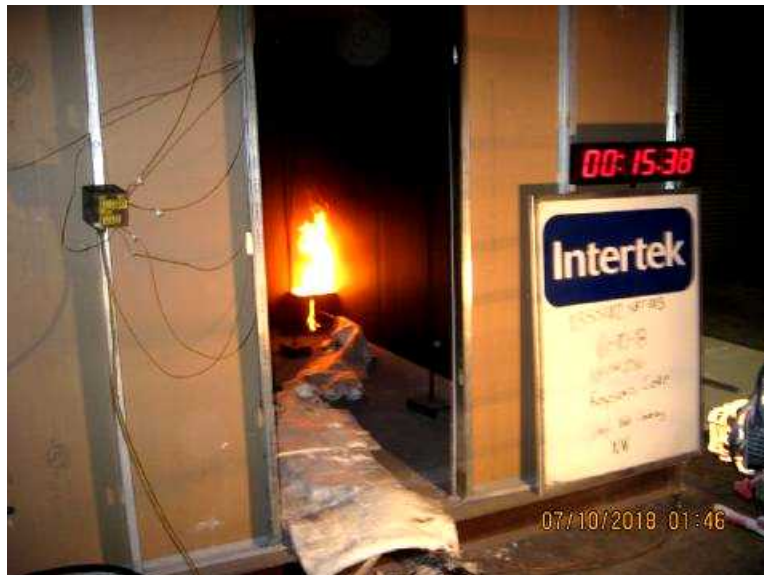
Photo No. 2
40kW

TEST OBSERVATIONS	
Time (Min:Sec)	Observations
00:00	Ignition of the burner. Heat output set at 40kW
00:10	Ignition of wall covering
00:28	Flaming 4ft vertically in corner above burner
00:30	Light smoke
01:12	Flaming 5ft vertically above burner
01:34	Flame tips intermittently reaching 8ft
01:38	Flaming 6ft above burner
02:00	Flames recede to burner
03:30	No change
05:00	Increase gas flow to 160kW
05:10	Ignition at ceiling level
05:16	Horizontal flaming at 5ft along ceiling
05:24	Increase in smoke – Black in color
05:41	Flaming 6ft back wall – 4ft sidewall burner side
06:15	Flames recede back to burner – reduction in smoke
07:09	Blistering on walls
09:16	Intermittent flaming back wall 4ft
09:36	Ignition back wall
10:07	Flaming on back wall ceased
12:00	No change
14:00	No change
15:00	Gas off – No after flames

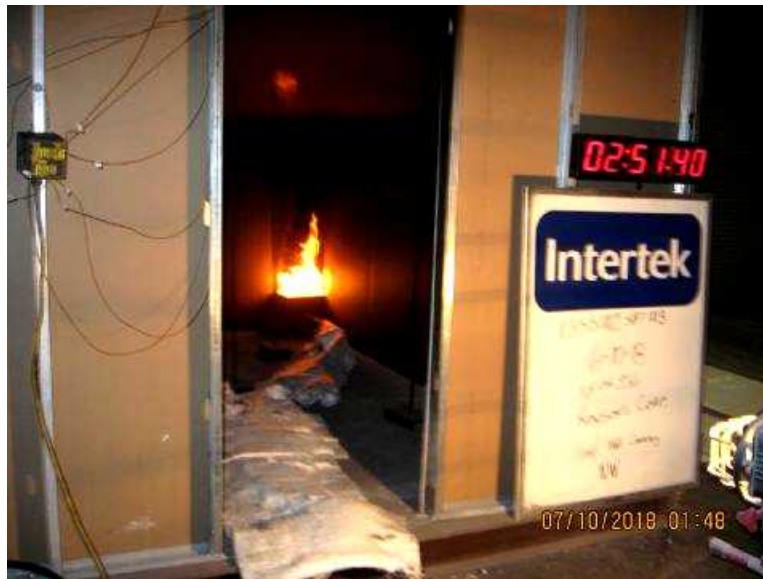
Photo No. 3
40kW

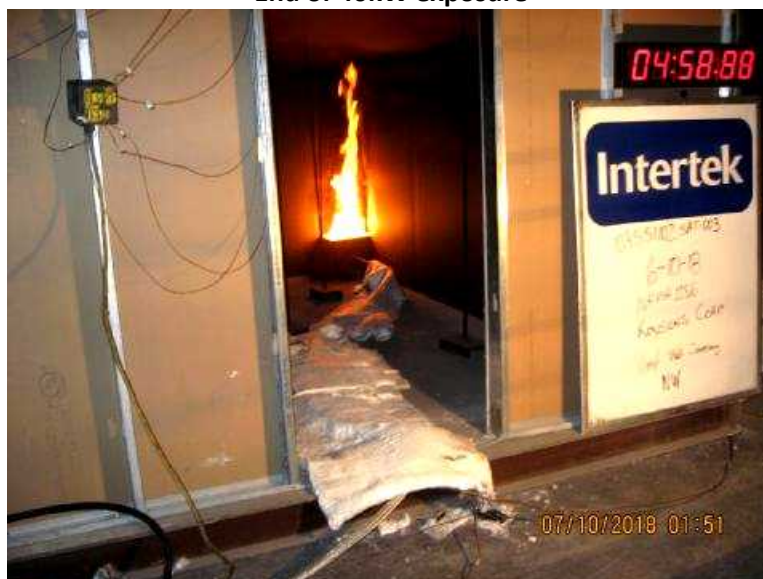
Photo No. 4
End of 40kW exposure

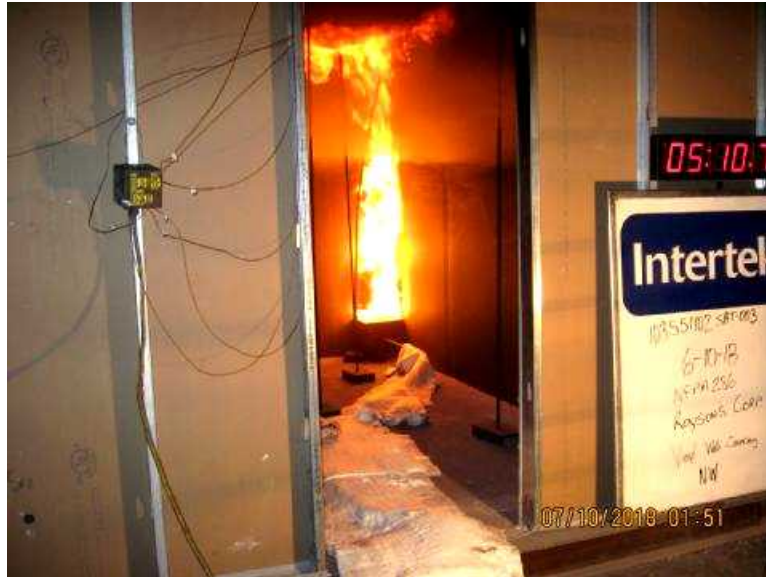
Photo No. 5
160kW

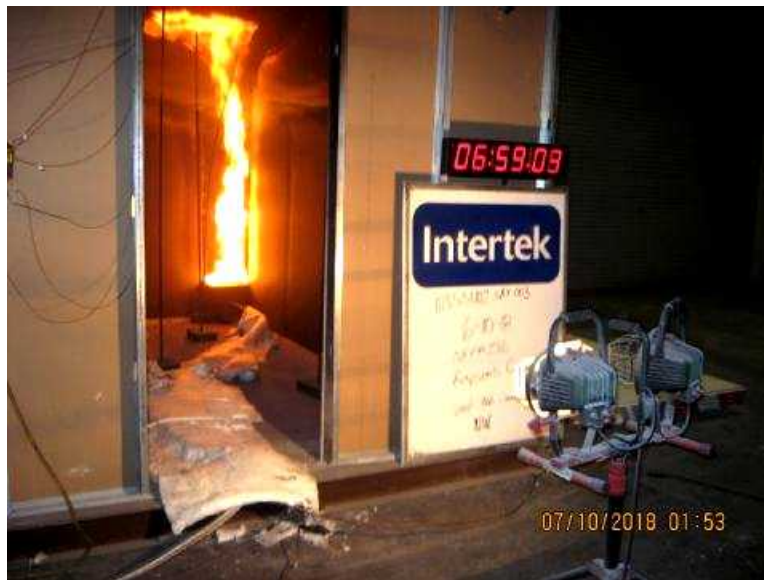
Photo No. 6
160kW

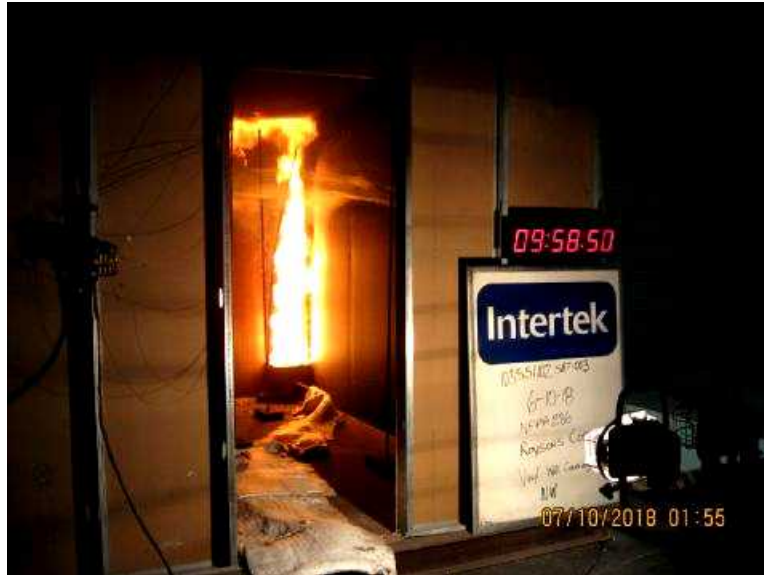
Photo No. 7
160kW

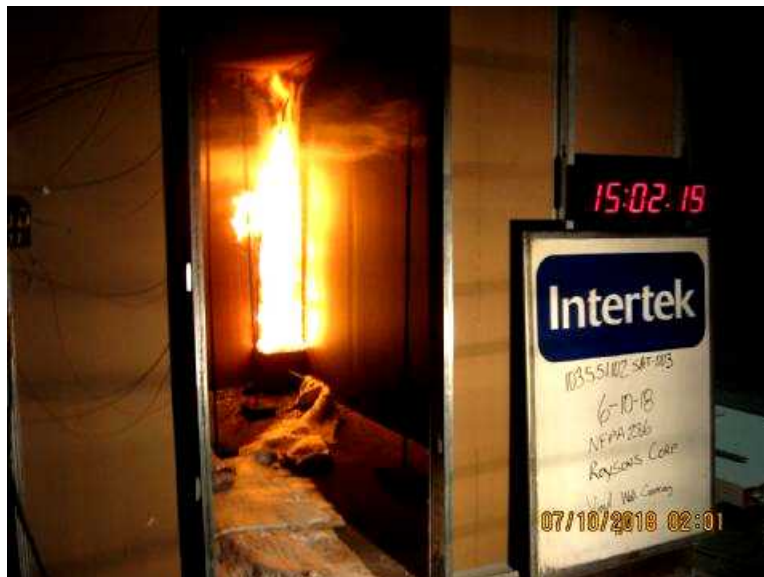
Photo No. 8
End of test

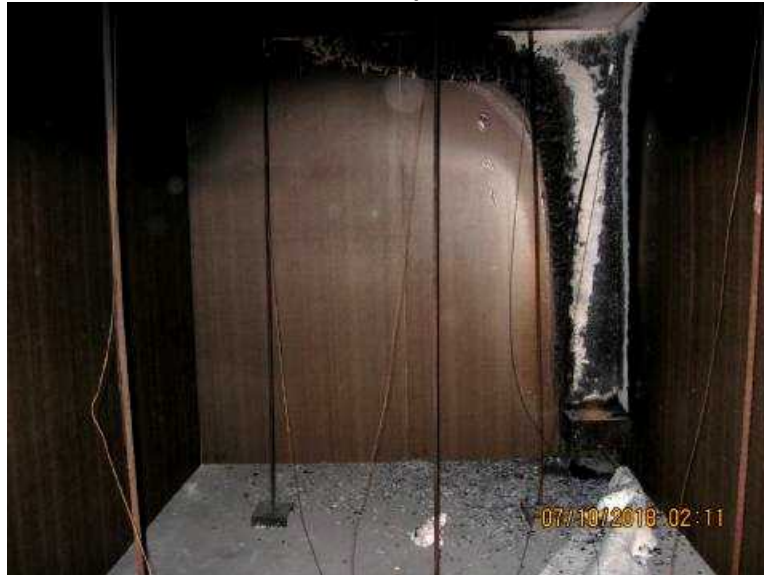
Photo No. 9
Post-test photo

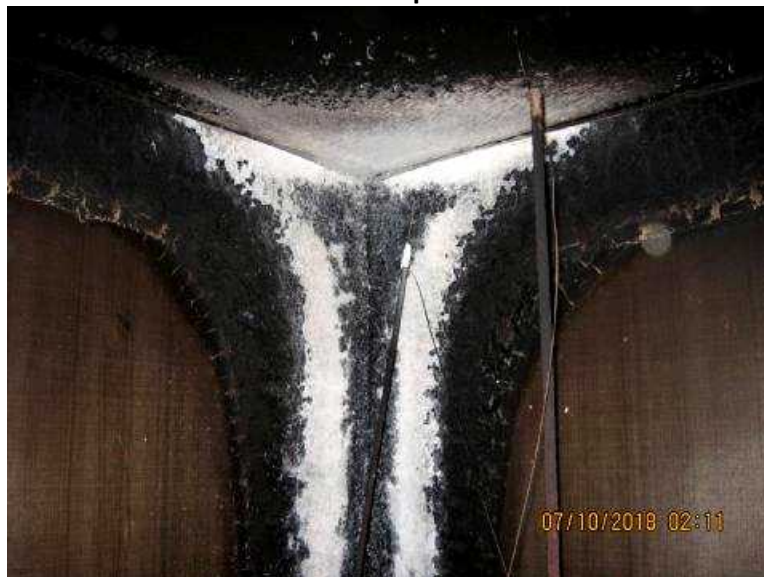
Photo No. 10
Post-test photo

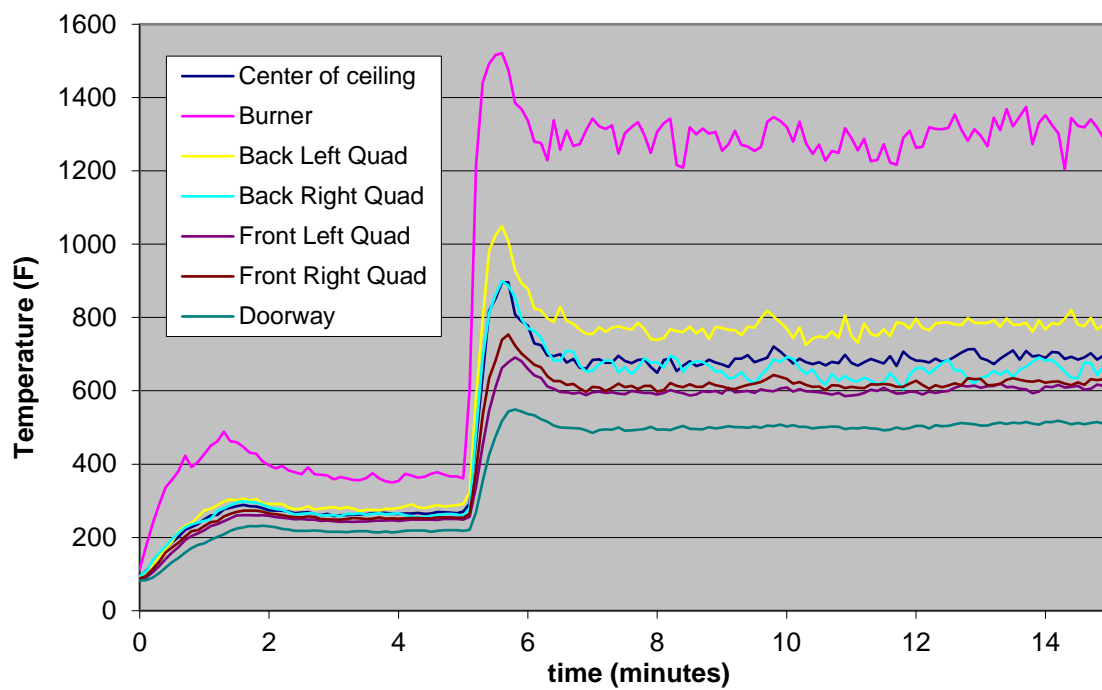
Graph No. 1
Thermocouple Data

2015 IBC SECTION 803.1.2.1 & NFPA 286 ANNEX C PERFORMANCE CRITERIA	TEST OBSERVATIONS	PASS/FAIL
During 40 kW exposure, flames should not spread to the ceiling.	Flames did not spread to the ceiling during the 40kW exposure.	PASS
During the 160 kW exposure, the interior finish should not spread to the outer extremity of the sample on any wall or ceiling	Flames propagation to the outer extremities did not occurred during the 160kW exposure.	PASS
<p>During the 160 kW exposure, the interior finish should not flashover as defined by NFPA 286.</p> <ul style="list-style-type: none"> •Peak Heat Release > 1 MW •Floor Heat Flux > 20 kW/m² •Average Upper Layer Temperature > 1,112°F •Flames exiting doorway •Auto ignition of Paper Target <p>Flashover is considered to have occurred when any two of the above criteria were met during the test.</p>	<ul style="list-style-type: none"> •Peak Heat Release = 204 kW •Max Floor Heat Flux = 2.04 kW/m² •Max Average Upper Layer Temperature = 849°F •No Flames exited doorway •The flashover indicators did not ignite. 	PASS

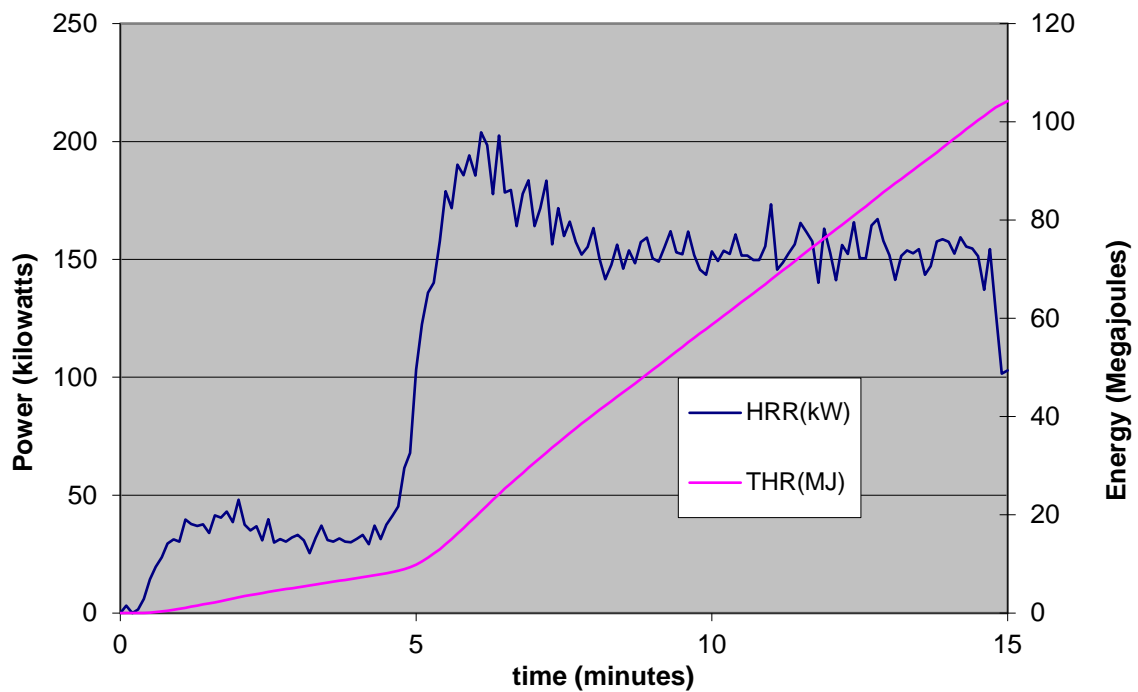
Graph No. 2
Heat Release Data

The peak rate of heat release throughout the NFPA 286 test should not exceed 800 kW.	The peak heat release rate was 204 kW	PASS
The total smoke released throughout the NFPA 286 test should not exceed 1,000 m ² .	The total smoke released during the entirety of the test was 11.9m ²	PASS

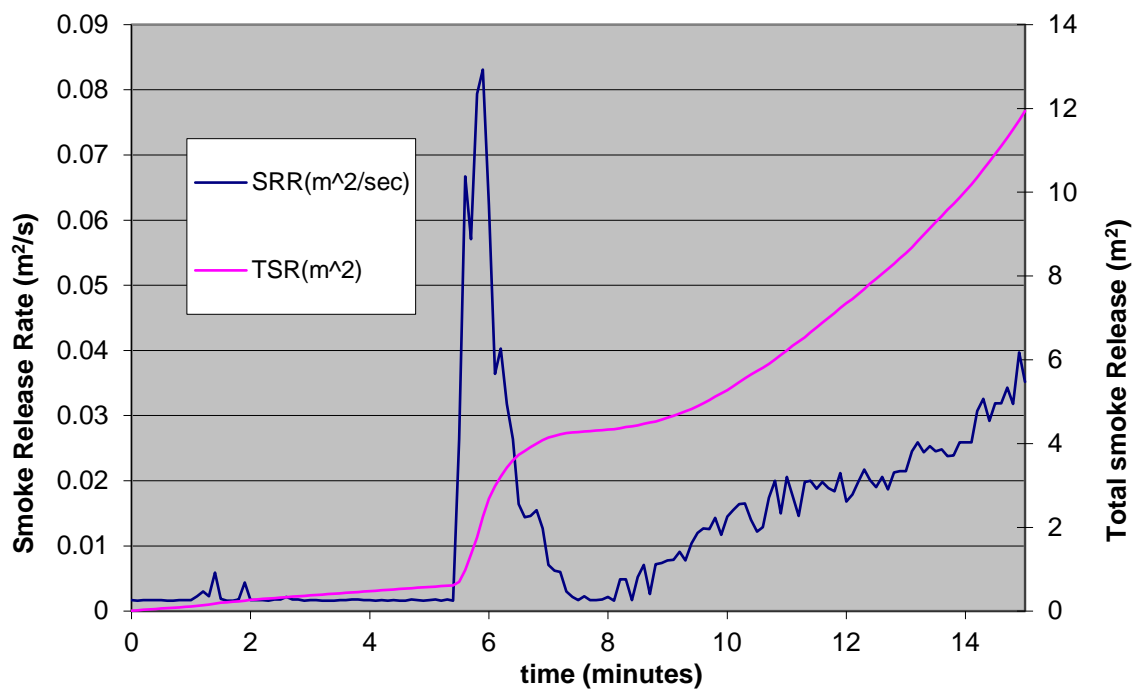
Graph No. 3
Smoke Release Data

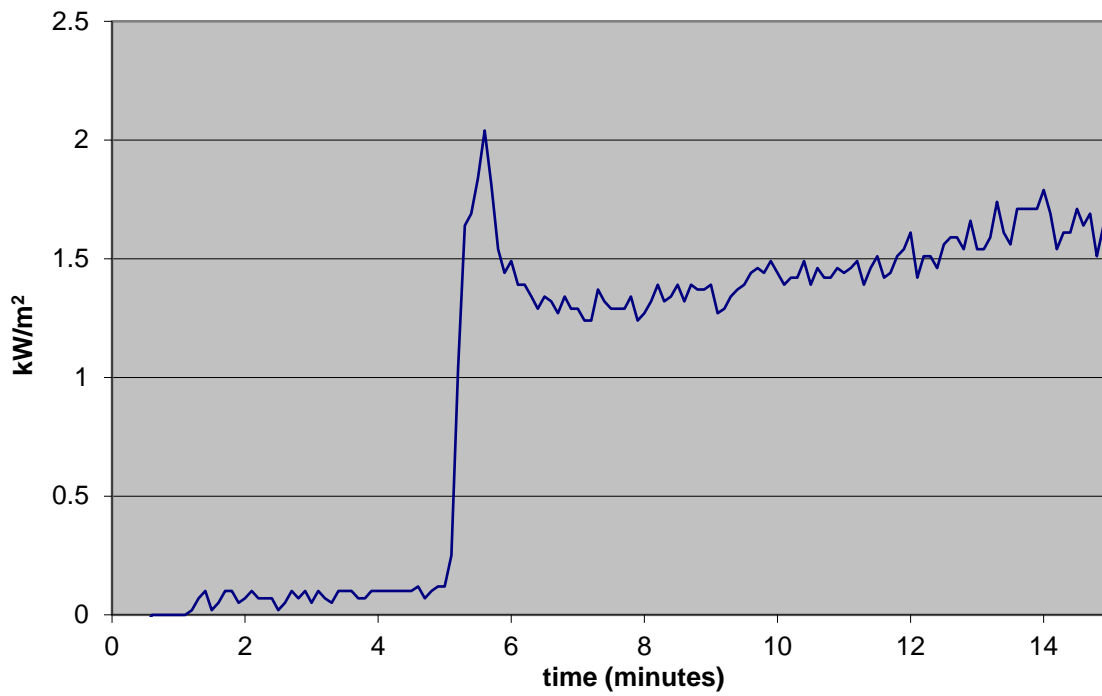
Graph No. 4
Floor Heat Flux

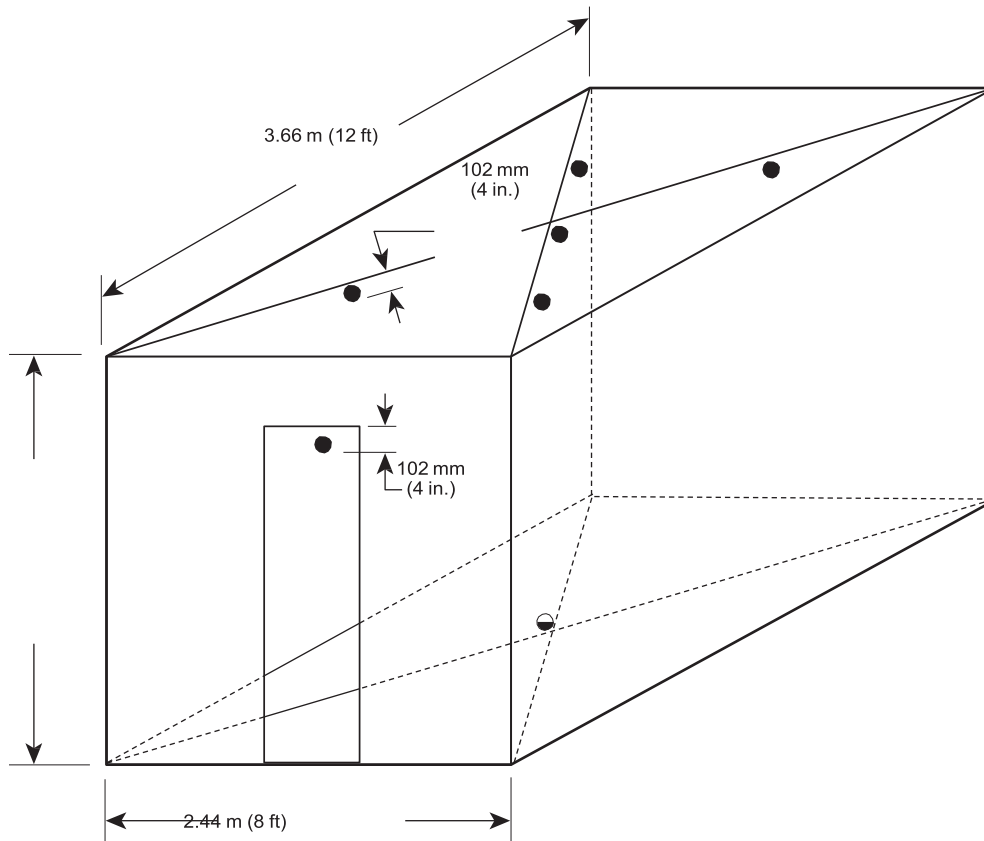
TC and Radiometer locations

The interior dimensions of the floor of the fire room, when the specimens are in place, measures 8 feet, by 12 feet. The finished ceiling is 8 feet \pm 0.5 inches above the floor. The four walls are at right angles defining the compartment. The compartment contains a 30 inches wide (\pm ¼ inch) by 80 inches high (\pm ¼ inch) doorway in the center of the 8 feet by 8 feet wall on the edge of the hood calorimeter apparatus. No other openings are present to allow ventilation. Below is a detailed description of the assembly:
